**HIGHLY EFFICIENT, RESOURCE-SAVING TECHNOLOGY FOR  
THE HIGHLY EFFICIENT, RESOURCE-SAVING TECHNOLOGY FOR  
THE RESTORATION OF STRUCTURES OF COMBINED ROOFING OF  
LARGE-SPAN BUILDINGS OF ELECTRICAL ENGINEERING**

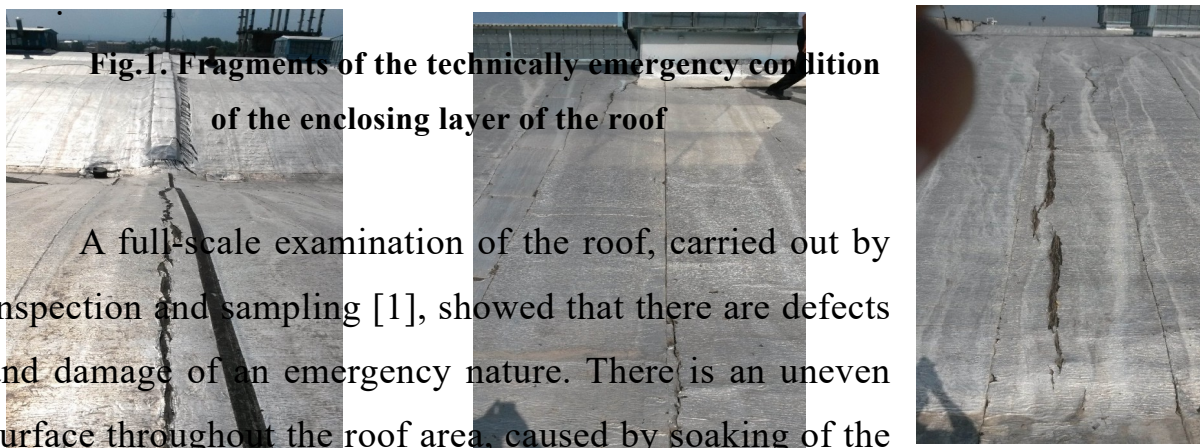
**Fig.1. Fragments of the technically emergency condition of the enclosing layer of the roof**

A full-scale examination of the roof, carried out by inspection and sampling [1], showed that there are defects and damage of an emergency nature. There is an uneven surface throughout the roof area, caused by soaking of the

screed and insulation material, There are excessively open through cracks reaching up to 30-35 mm (Fig.1).. Through cracks in the waterproofing layers occupy within 21-23% of the total roof area, norms allow the production of restoration work with physical wear of structures up to 60 percent [10].

This led to a change in the design model of the supporting structure of the carpet [7], as a beam on an elastic base with uneven stiffness, which worsened the structural work of the roof, since mineral (glass) wool does not have uniform stiffness, which means it does not protect the upper layers of the roof from uneven deformation, and will not be able to distribute possible cracks along the entire area. The accumulation of deformations along the length of the roof led to the rupture of the screed and rolled carpet layer up to 30-35 mm, at each 14-15 meters in length.

6. It is necessary to arrange deformation seams (10-12 mm wide) along the lines of through cracks (approximately on each 14-15 m length of the roof) [3];

7. Arrange additional deformation seams (10-12 mm wide) in the middle between emergency through cracks (approximately on each 7-8 m length, parallel to the direction of the roofing carpet) [6];

8. Seal the expansion joints with a soft hermetic material or bitumen, lay the usual layers of waterproofing carpet on top of the seams;

9. In areas of the roof with cracks at an oblique angle, after sealing the screed with cracks, lay rolled waterproofing materials, preferably from foil insulation. On the roof restoration project, to provide and implement in the process of reconstruction the release of the edge of the rolled material at least 200 mm from the crack face.
