**STUDY OF EXISTING HYDROTECHNICAL STRUCTURES AND
THEIR TECHNICAL CONDITION AT THE HEAD DAM OF THE
"DOSTLIK" CANAL**

The main structure of the "Dustlik" canal is located in the Bekabad district of the Tashkent region. According to the management system, it is part of the "Mirzachul Hydro-Construction and the Dustlik Canal" department of the Syrdarya Basin Water Management Association. The geological structure of the structure base consists of light sandy loam (loam) and some gypsum loam (supes) and sand, with seepage waters located at a depth of 2...4 m. The layer thickness is 30-50 m. The filtration coefficient of the soils is 5 - 7 m per day. The mineralization of groundwater is 1.0...3.0 gpl, the type of mineralization: hydrocarbonate-chloride (sodium; magnesium; calcium).

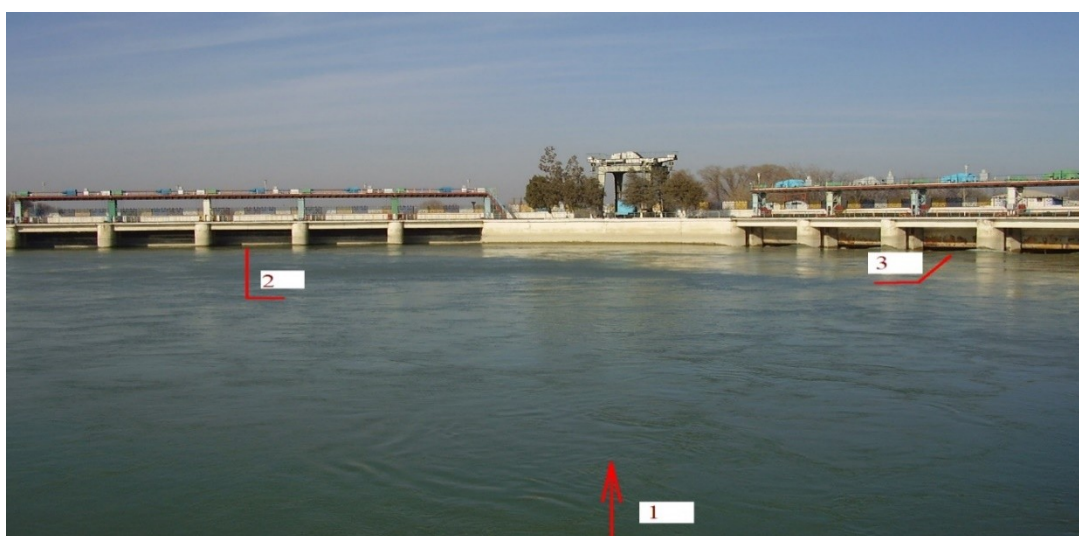
Figure 1. Water intake basin.

The water supply channel is trapezoidal in shape. The width of the opening is 80 m, the maximum depth is 6.06 m and the height of the hole is 2.0 m. The mark of the canal at the mouth of the hydroelectric unit is 282.10 m, the maximum water level in the canal is 288.16 m, the normal water level is 286.73 m, the mark of inshoot damming is 288.70 m. Water feeder channeling maximum water consumption 470 m³ / sec.

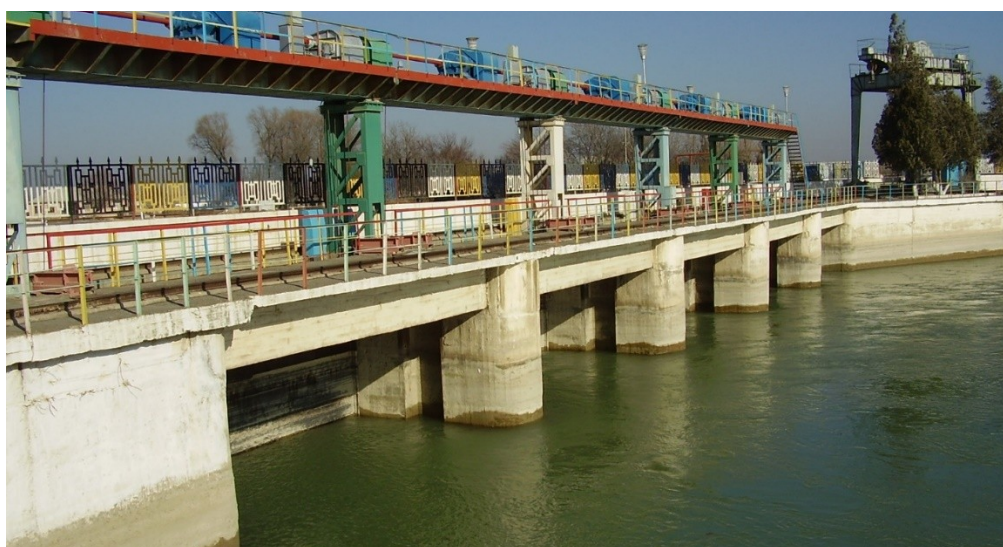
Figure 2. "Dustlik" channel main building.

The main structure design is open. The number of spans is 5. The span dimensions are 10.0 x 5.35 m. The main structure spans are equipped with flat working locks with a maximum pressure of 6.06 m. Devices for repair locks are made in front of the working locks. A port crane with a width of 6.0 m and a lifting capacity of 30 t is installed to lift and lower the working and repair locks. Lock control is controlled from the dispatcher's room or from the site. The spans of the structure are equipped with sensors indicating the state of the lock.

The main structure has four concrete spans, the dimensions of which are: length - 16.7 m, thickness - 2.0 m, height - 6.8 m. A crane road, service and automobile bridges are built on the spans.

The main structure's culvert is made of concrete, its dimensions are: length - 15 m, width - 58 m, and thickness - 0.4 m. In the front part of the culvert, the bottom and banks of the water supply channel are reinforced with large stone rubble. The culvert elevation is 282.10.

The water energy discharge well built in the downstream of the main structure is 56.45 m long and 62 m wide. The water well is made of concrete and its thickness varies along its length, that is, it is 2.3 m thick at the entrance and 1.0 m at the end. To additionally absorb the water energy, a series of checkers

with a width of 1.0 m, a height of 0.9 m and a length of 1.6 m are installed inside the well.

A berm 15 m long was created at the end of the water well by quarrying large stones. The water-carrying channel of the main structure is made of earth and its dimensions are as follows: the width of the bottom is 40.0 m, the slope of the bank is 2.0.

The main structure is connected to the trapezoidal channel at the front with a “revolving wall” type entrance, and to the water-carrying channel at the back with a wing in the form of a “plunging wall” with a length of 19.75 m.
