# HAZARDOUS EXOGENIC PROCESSES OCCURRING IN THE AMIRSOY RESORT AREA AND ADJACENT MOUNTAIN SLOPES AND THEIR ANALYSIS

**Abstract.** *This article highlights field survey work carried out at the Amirsoy ski resort and adjacent slopes in Bostanlyk District of Tashkent Region of Uzbekistan.*

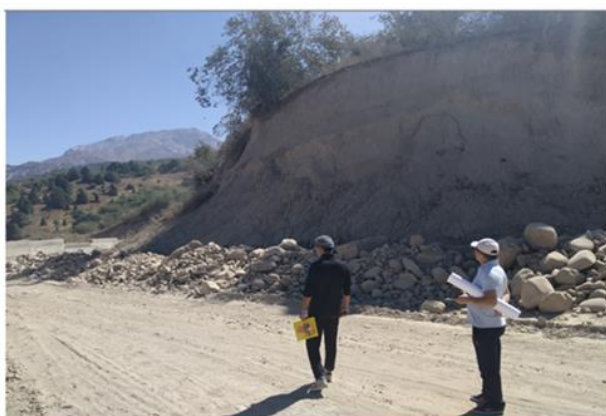
soil moisture under the influence of spring water, the presence of loess and loess-like rocks with high water capacity, decreased strength of rocks, increased gradient of the slope, etc. (Figure 2). This circumstance leads to the occurrence of slope collapses on some sections of the road, surface erosion, landslides, resulting in deformation of the roads and their overlapping by landslide rocks. Special measures (e.g. trees planted as terraces, drainage wells and special protection structures) were applied in road sections where the above situations could occur (Fig.3,4).

**Figure 2.** The situation on the slopes cut for road construction

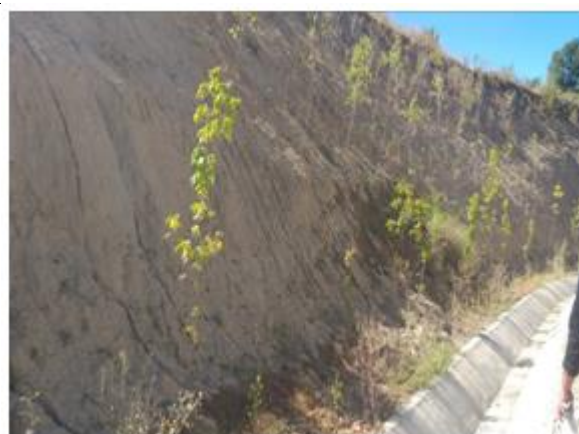
**Figure 3.** Seedlings planted as terraces

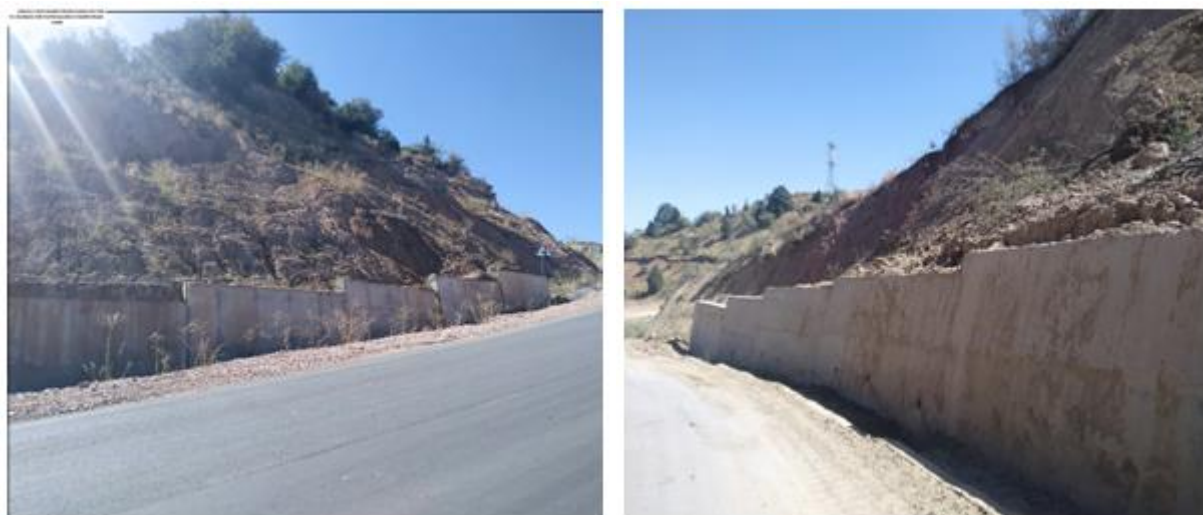
However, our observation revealed that some of the measures did not *fully* justify themselves, for example that the protection structure built was intended to contain a certain volume of landslide, but it was filled with landslide rock, which in some places exceeded the volume and rolled over the protection structure, causing it to shift (30-35 cm).

**Figure 4.** The protection wall was filled with sliding rocks and surpassed some parts

3. To ensure the adoption of protective measures to strengthen the slopes along which the ground is sliding, along the access roads to the territory of the resort Amirsoy. When building roads, additional cutting of mountain slopes must be avoided and protection structures must be built in the cut areas;

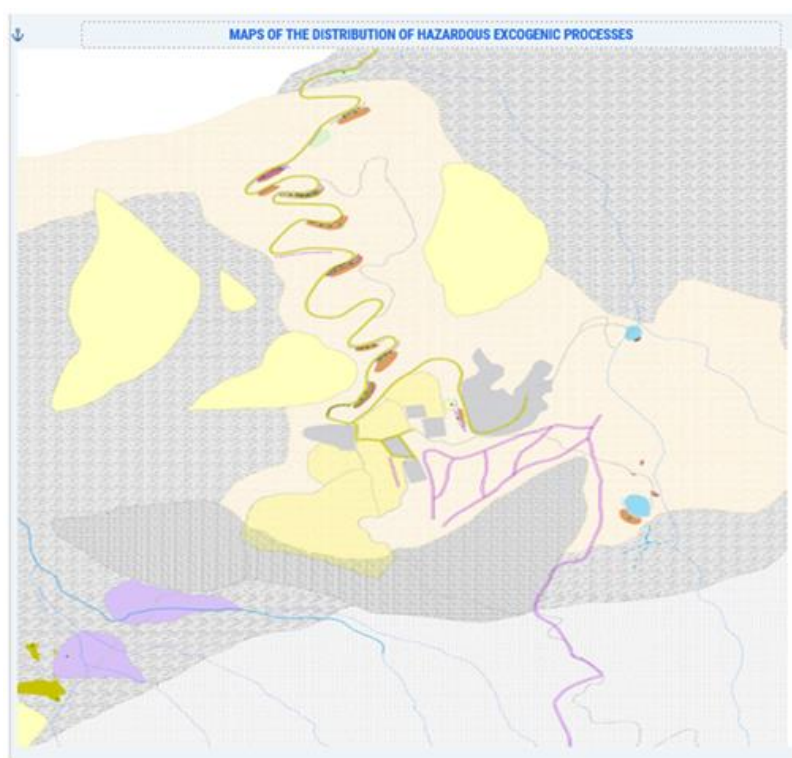
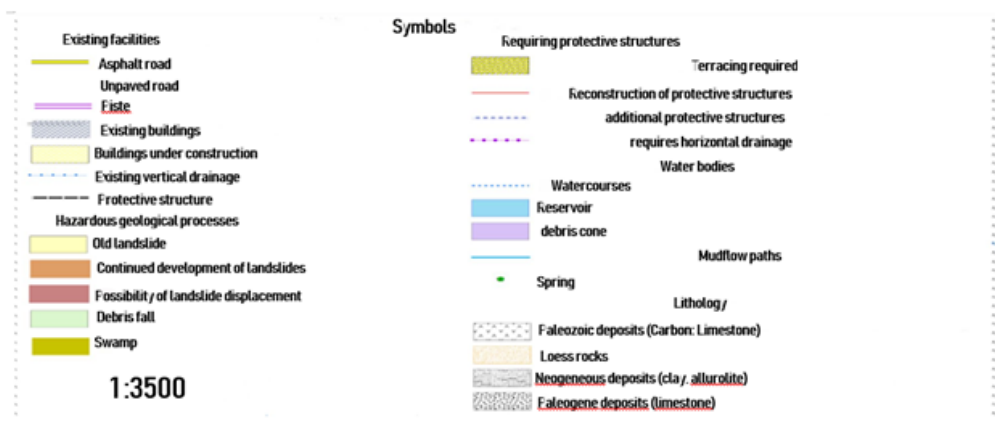
At the Amirsoy resort area, you can see cirques of ancient landslides in the middle and lower parts of the slopes, as well as in the “triangular” cuestas consisting of separately protruding Paleogene limestones. In addition, 7 large-scale ancient landslides were detected in the northern parts of the resort. The 2017-2018 survey identified 22 ancient and modern landslides. During our study (September 2021) it was observed that in some of them the landslide continued, 1 large-scale landslide (41 ° 29'52.95 "N, 69 ° 56'11.84" E) and several small landslides occurred (there are signs of sliding in about 10 places) (Figure 5).

**Figure 5.** Map of distribution of hazardous exogenic processes in the Amirsoy resort area

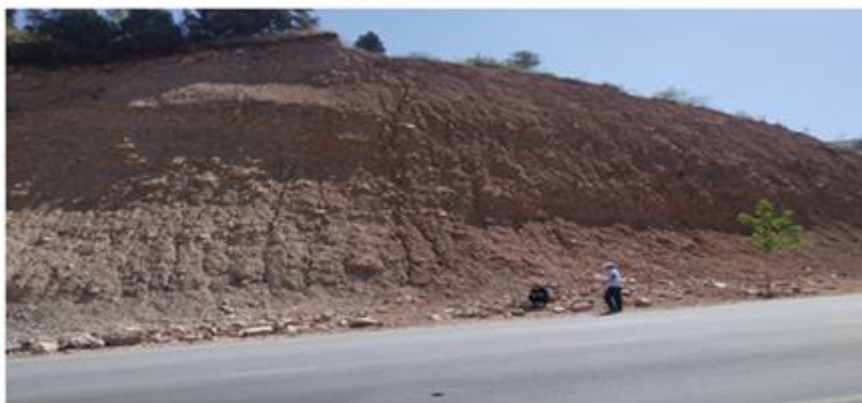
**Figure 6.** A slope where there is a risk of debris fall

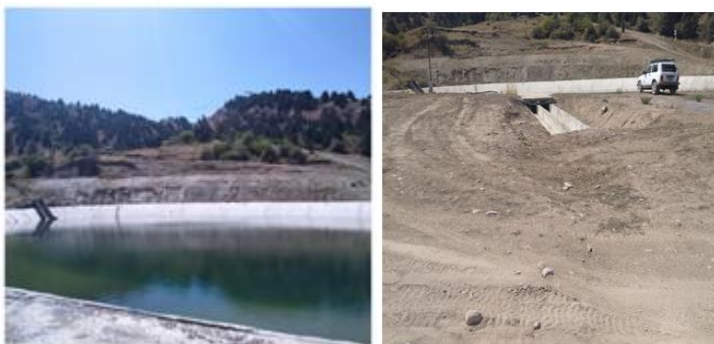
Mudflow channels around the Amirsoy resort area were also studied. A lot of snow accumulates in the upper part and the slope is steep; mudflows caused by melting snow (late March-early May) during the precipitation season did not have a negative impact on the resort area. At the convergence of several mudflow channels (sais), a reservoir for collecting mudflow water and an additional drainage channel were built. This measure will reduce the risk of mudflows and provide an additional source of water in the summer (Figure 7).

**Figure 7.** A reservoir to collect mudflow water
